NIST NCSTAR 1-6
Federal Building and Fire Safety Investigation of the World Trade Center Disaster

Structural Fire Response and Probable Collapse Sequence of the World Trade Center Towers

John L. Gross
Therese P. McAllister
Building and Fire Research Laboratory
National Institute of Standards and Technology

September 2005

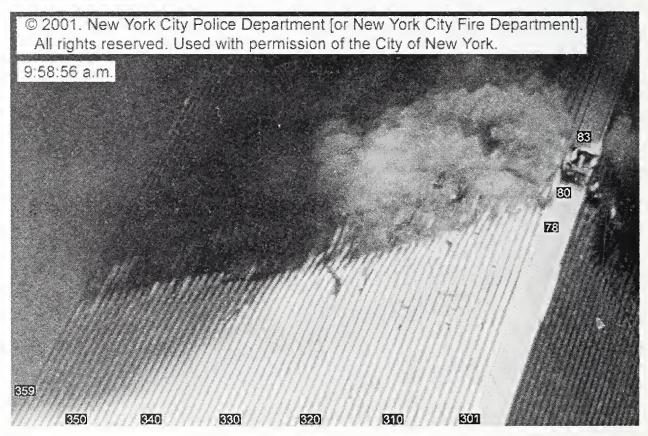
Figure E-7. View of WTC 2 buckling of east wall near northeast corner as collapse initiates from southeast.

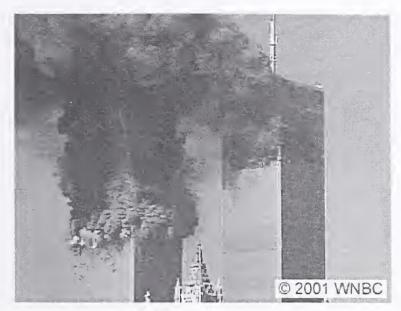
- The building section above the impact and fire area tilted to the east and south as the structural collapse initiated as shown in Fig. E–8. There was approximately a 3 to 4 degree tilt to the south and a 7 to 8 degree tilt to the east prior to significant downward movement of the upper building section.

Figure E-8. View of upper building section of WTC 2 tilting to the east.

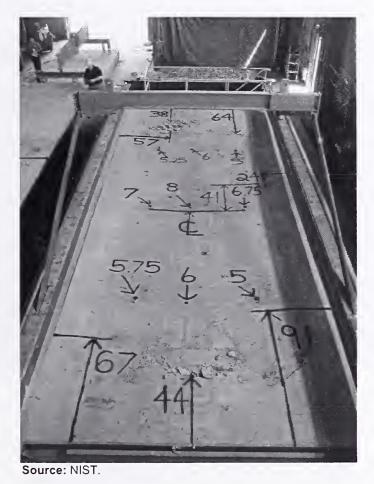
At about 50 min, a very loud report was heard, associated with a noticeable sudden downward deflection of the specimen. When access to the top of the slab was possible after completion of the test, it was found that significant cracking and dislocation of the slab had occurred near the corners of the slab. Several of these events were recorded, and post-test inspection revealed that concrete failure had occurred in all four corners of the slab as shown in Fig. 3–7. It is believed that the very loud report and abrupt deflection was a result of the sudden concrete cracking. The test was stopped at 116 min when, after another sudden drop, the center span deflection reached about 15 in.

Figure 3–7. Unexposed surface of Assembly No. 1 after loading equipment was removed.

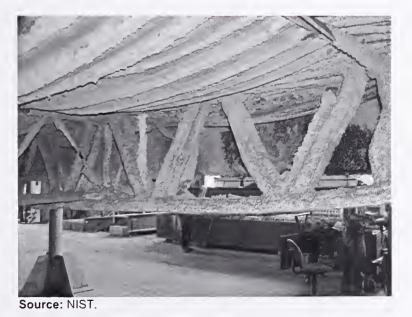
A photograph of the underside of the 35 ft, restrained test specimen after almost two hours of fire exposure is shown in Fig. 3–11. Buckling of the compression diagonals can be seen as well as sagging of the metal deck between supports. Note that, upon cooling, the test specimen recovered at least half of the deflection achieved during the test so deflections seen in Fig. 3–11 are considerably less than the deflections at the end of the test.

Figure 3–11. Fire exposure side of the 35 ft restrained test assembly after almost 2 hours of fire exposure

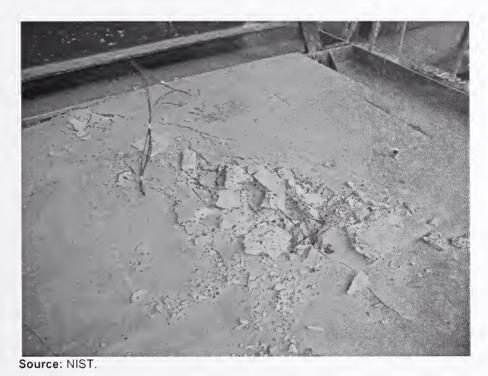
The three specimens that were restrained showed significant cracking and explosive spalling at the top surface of the concrete slab. The 35 ft restrained specimen had significant cracking and crushing of concrete near the ends and the corners as seen in Fig. 3–7 and Fig. 3–14. These major concrete failures were accompanied by sudden increases in deflection of the floor as seen in Fig. 3–15. The unrestrained 35 ft specimen showed little cracking and no crushing or explosive spalling at the top surface of the slab unlike the restrained specimen. The restrained 17 ft specimen with ½ in. of SFRM exhibited significant explosive spalling in which concrete fragments flew in the air and left a hole in the slab about 2 ft long through which hot gases escaped.

Figure 3-14. Detail of spalling concrete at east end of Assembly No. 1.

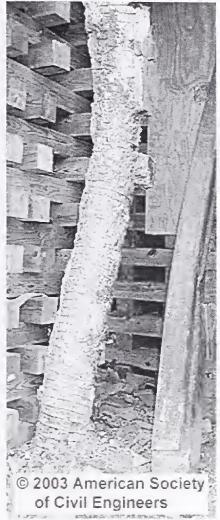
It is the light damage that is of interest relative to insulation damage from aircraft impact. Reinforced concrete columns have a concrete cover of at least one inch, and typically more, over the steel reinforcement. Figures 5–26 and 5–27 show two examples of columns with their concrete cover stripped by the debris field down to the spiral reinforcement over most of the column height. It was assumed that if the debris field could strip away concrete cover then a similar debris field would strip SFRM from steel components.

Figure 5–26. Typical damage to spirally reinforced columns in the Pentagon impacted and bent by large debris (ASCE, 2003).

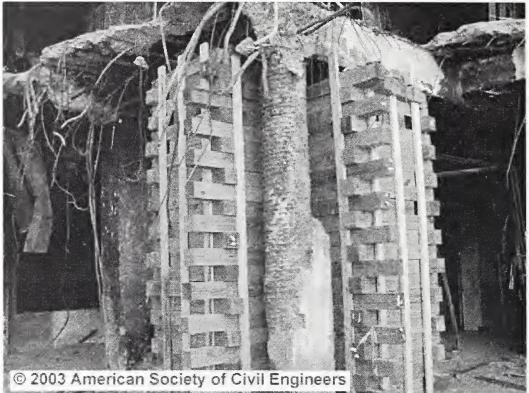
Figure 5–27. Typical damage to spirally reinforced columns in the Pentagon not impacted or bent by large debris (ASCE, 2003).

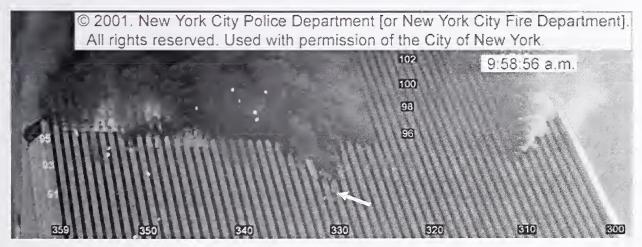
Figure 6–4. South face of WTC 1 with fire visible only on the west side at 9:25. Arrow shows region where debris pile under missing panel was observed.

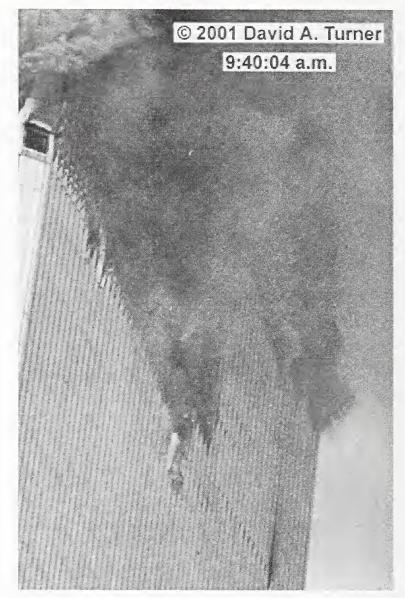
Figure 6-5. Fires on WTC 1 south face at 9:40 a.m. Note lack of inward bowing.

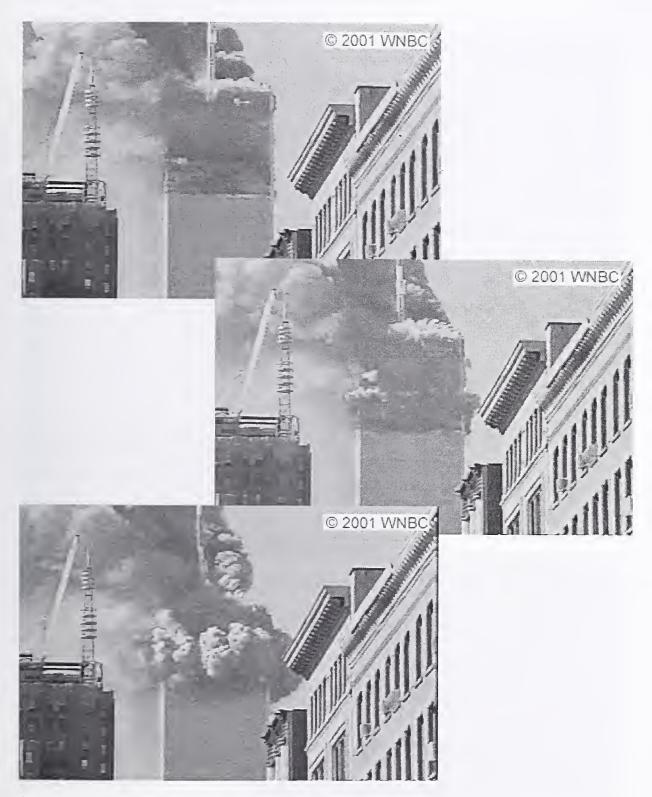
Figure 6–10. Rotation of WTC 1 building section above the aircraft impact zone toward the south as viewed from due north. Note that there is no tilt in the east or west directions.

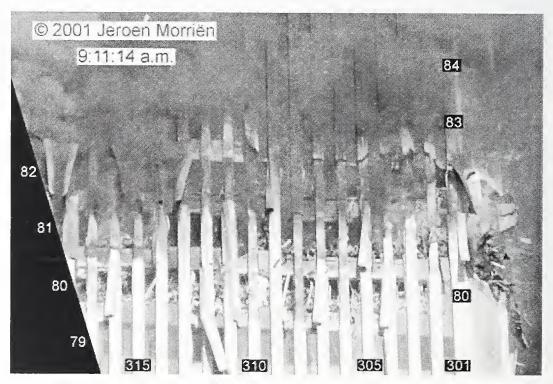
Figure 6-14. Debris piles at windows where fires are burning at the northeast corner.

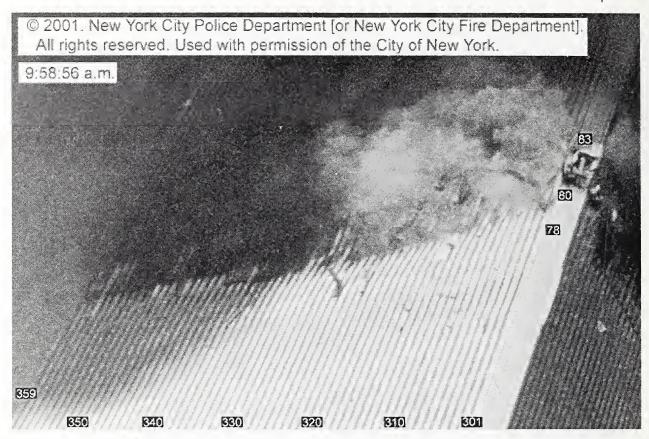
Figure 6–21. WTC 2 exterior columns bowing inward across the east face between Floors 77 and 83 at 9:58:55 a.m.

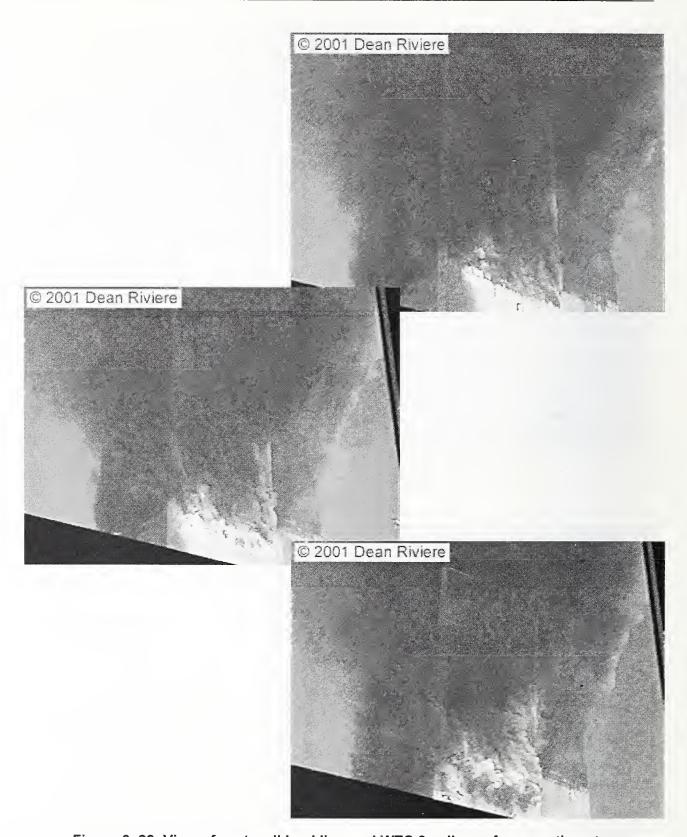
Figure 6–23. View of east wall buckling and WTC 2 collapse from southeast.

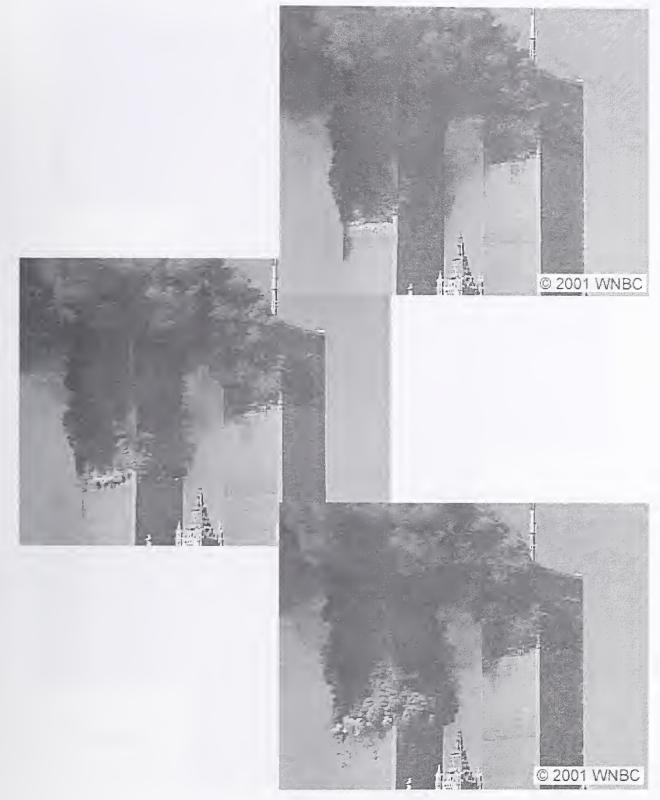
Figure 6–24. View of upper building section of WTC 2 tilting to the east.

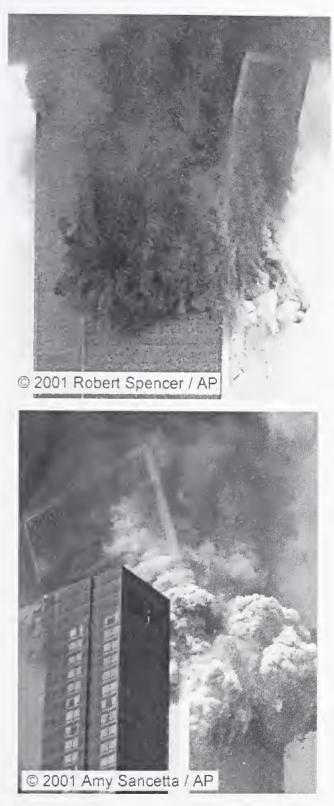
9:59:02	~ 106	SE + E		Fig. 6–26	Kink (and offset) about Floor 106 which propagates across the east face where degrades into a gentle curve on the northeast corner; indicates that the kink did not precede the initiation of the global collapse.

Figure 6–26. Kink on southeast corner near Floor 106 formed after collapse initiation.
